Manhole Inspection Summary

Manhole # S39K__015MH

Insp Date: **12/15/08 1:58 PM**

Location Address: **824 eastern av**

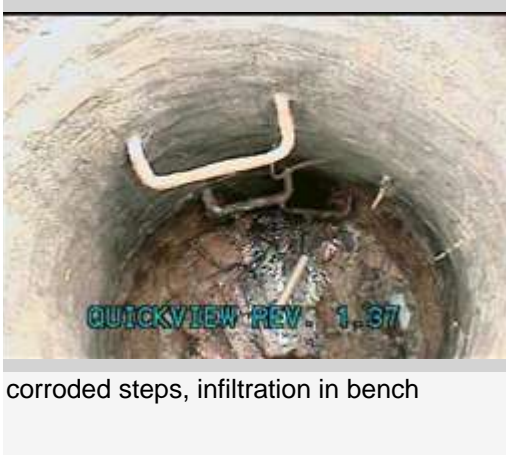
Defect 2

Condition: ☐ Sound ☐ Cracked ☐ Root Intrusion ☐ Deteriorated ☒ **Leaks** ☐ Debris

Steps Count: **4** Missing: **1** ☒ **Corroded**

corroded steps, infiltration in bench

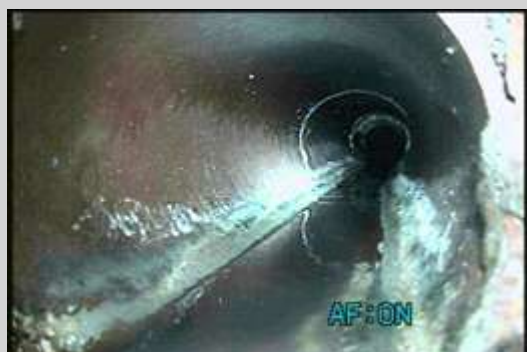
12 O'Clock Outflow

8 in. Circular Gravity Sewer
Pipe Out @ 12 O'Clock

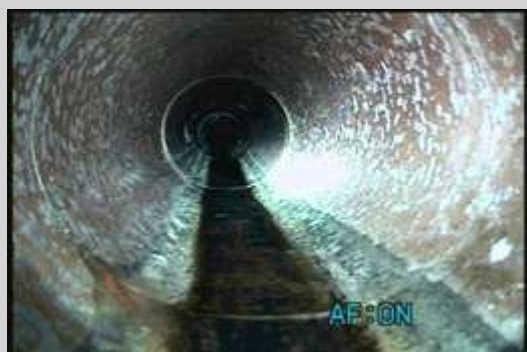
3 O'Clock Inflow

8 in. Circular Gravity Sewer
Pipe In @ 3 O'Clock
